2025/11/30 05:51 1/2 bad_solderings_gallery

This gallery shows some pictures of bad solderings - they should prevent you from making the same errors (feel free to add even more pictures here!)

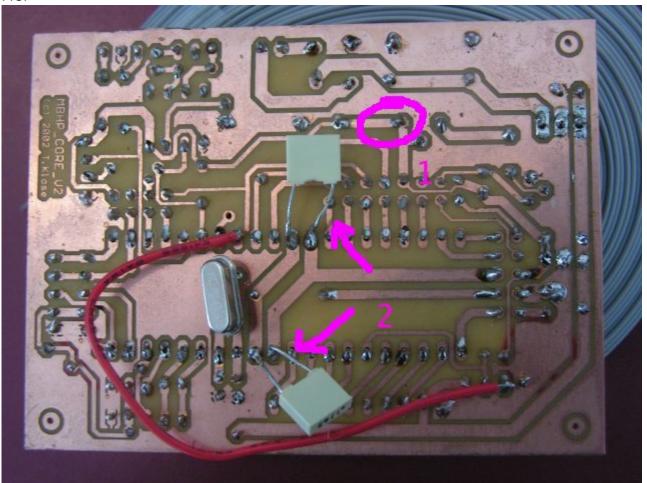
- 1: The core module has some badly soldered connections(loose), which could lead to failures. There are also missing solderings (e.g. 33pF cap below crystal). It makes sense to solder each pad again, the Soldering guide in the Wiki gives some useful tips
- 2: The legs of the caps should be cut, otherwise they can cause a short circuit which can damage the PIC!

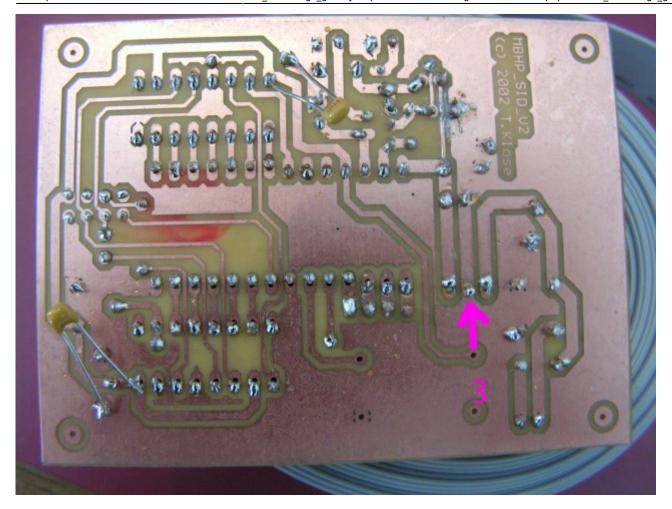
3: This seems to be a bad ground connection directly at the 78xx - it can lead to the wrong voltage. Here the same: just solder the pads again, it will help And same as above: the long cap legs need to be cut, the danger of shorting out is too high!
