This gallery shows some pictures of bad solderings - they should prevent you from making the same errors (feel free to add even more pictures here!)

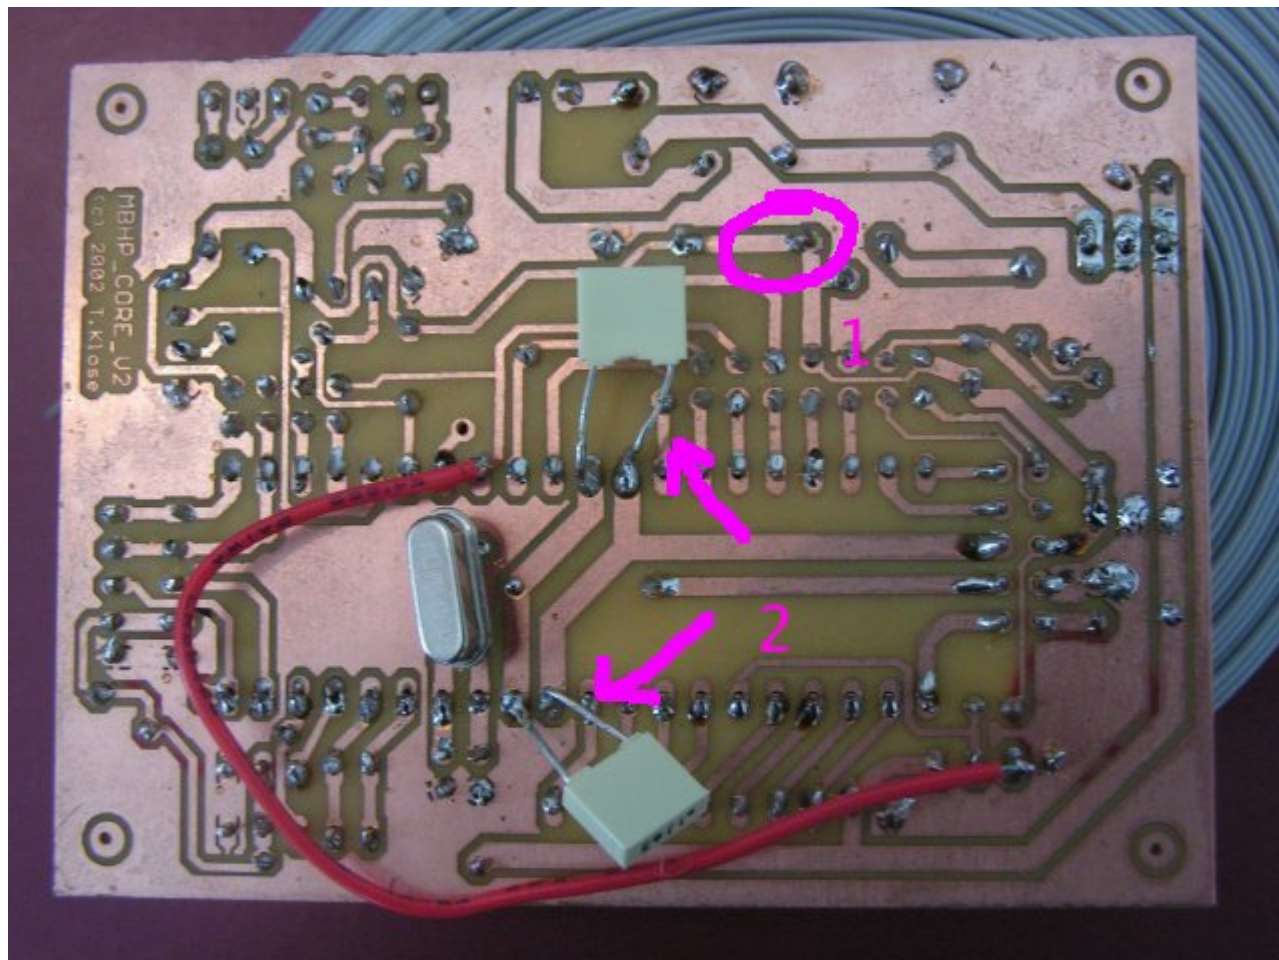
1: The core module has some badly soldered connections(loose), which could lead to failures. There are also missing solderings (e.g. 33pF cap below crystal). It makes sense to solder each pad again, the [Soldering](#) guide in the Wiki gives some useful tips

2: The legs of the caps should be cut, otherwise they can cause a short circuit which can damage the PIC!

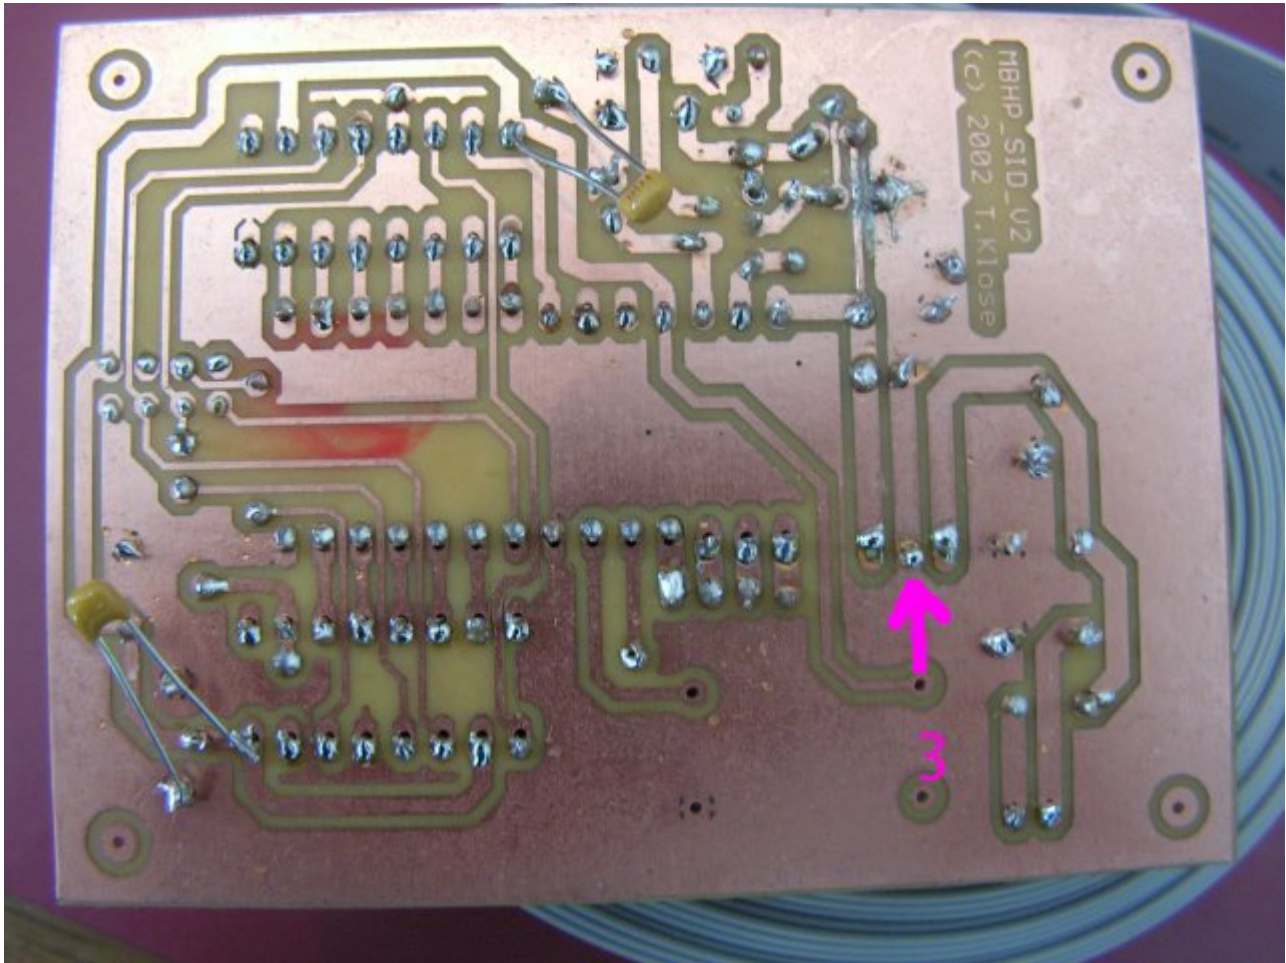
3: This seems to be a bad ground connection directly at the 78xx - it can lead to the wrong voltage. Here the same: just solder the pads again, it will help
And same as above: the long cap legs need to be cut, the danger of shorting out is too high!
