This gallery shows some pictures of bad solderings - they should prevent you from making the same errors (feel free to add even more pictures here!)

Permanent link:
https://www.midibox.org/dokuwiki/doku.php?id=bad_solderings_gallery

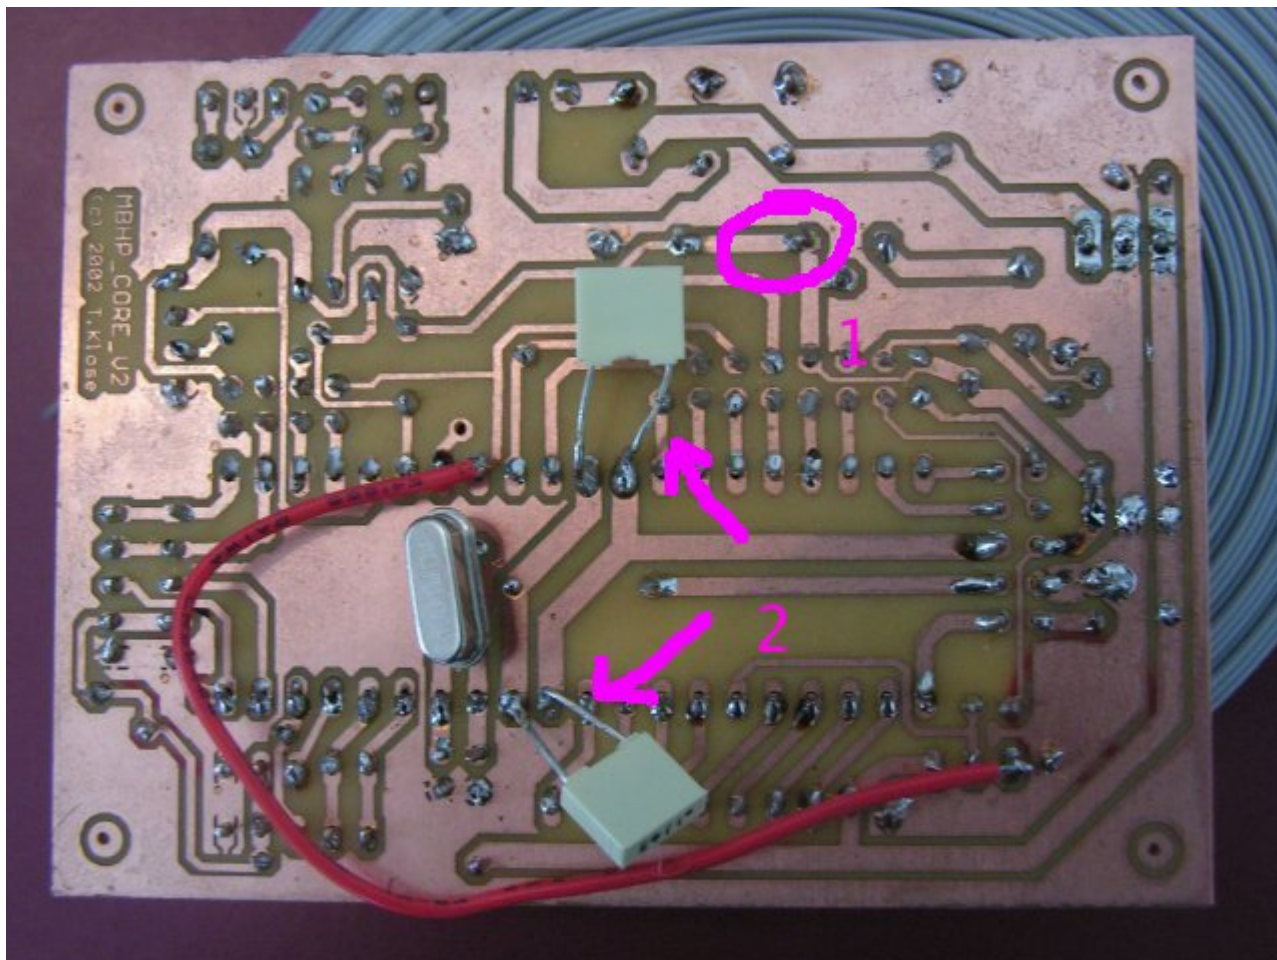
- 1: The core module has some badly soldered connections(loose), which could lead to failures. There are also missing solderings (e.g. 33pF cap below crystal). It makes sense to solder each pad again, the [Soldering](#) guide in the Wiki gives some useful tips
- 2: The legs of the caps should be cut, otherwise they can cause a short circuit which can damage the PIC!

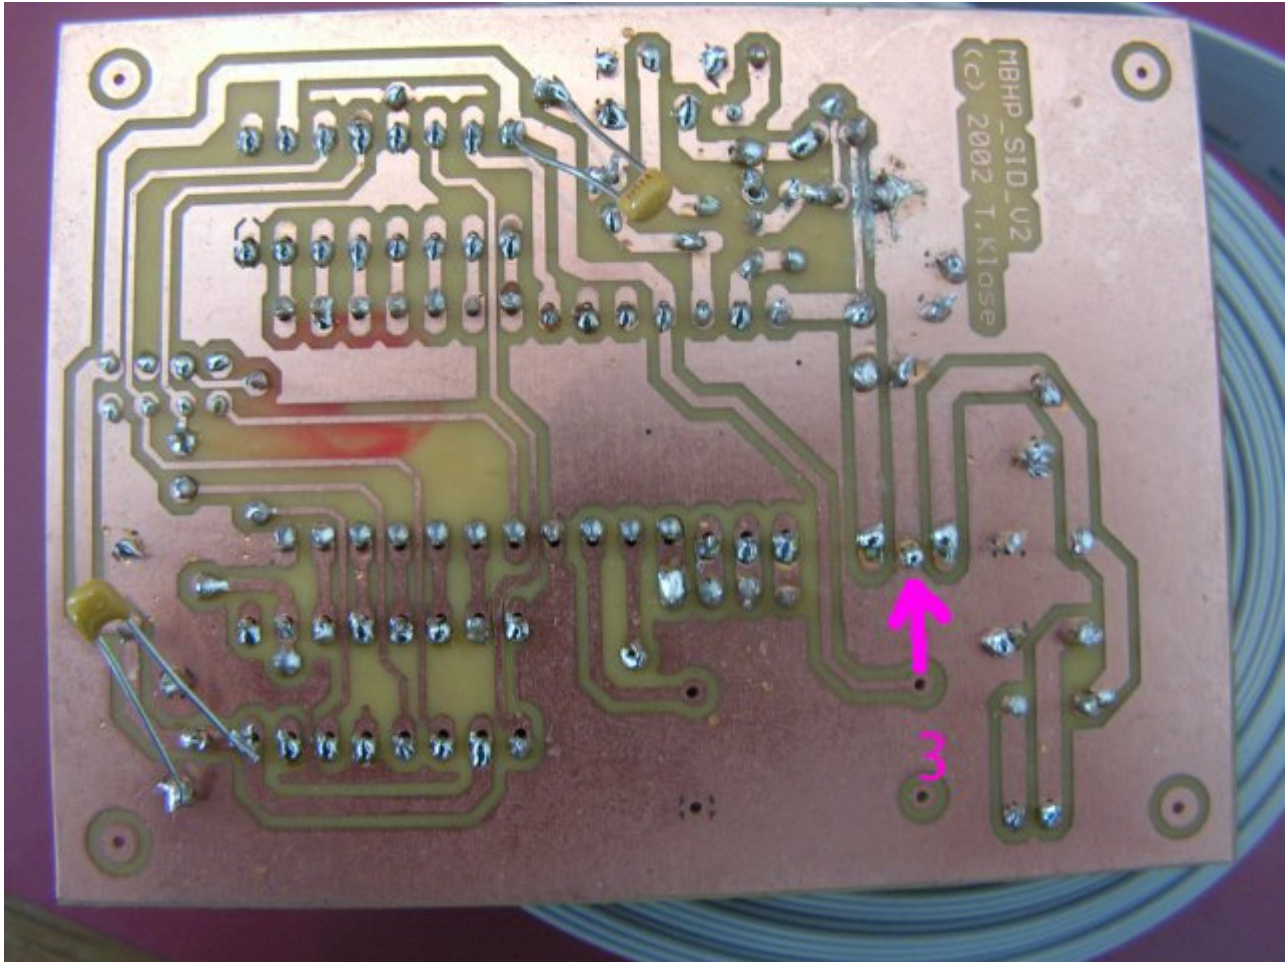
- 3: This seems to be a bad ground connection directly at the 78xx - it can lead to the wrong voltage. Here the same: just solder the pads again, it will help
And same as above: the long cap legs need to be cut, the danger of shorting out is too high!
