This gallery shows some pictures of bad solderings - they should prevent you from making the same errors (feel free to add even more pictures here!)

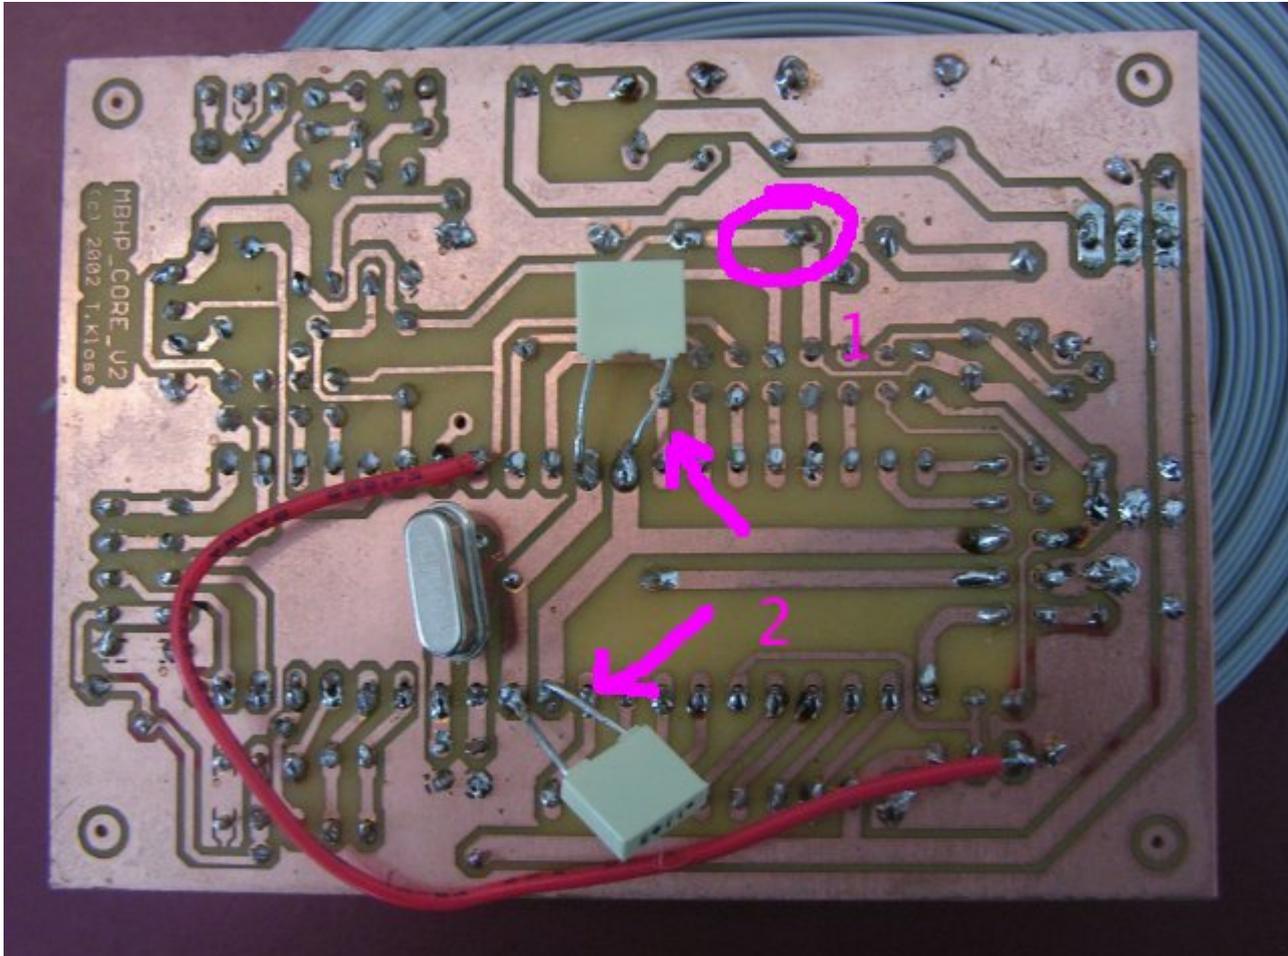
1: the core module has some bad solderings (loose connections), which could lead to failures. There are also missing solderings (e.g. 33pF cap below crystal). It makes sense to solder each pad again, the [Soldering](#) guide in the Wiki gives some useful tips

2: the legs of the caps should be cutted, otherwise they can cause a short circuit which can damage the PIC!

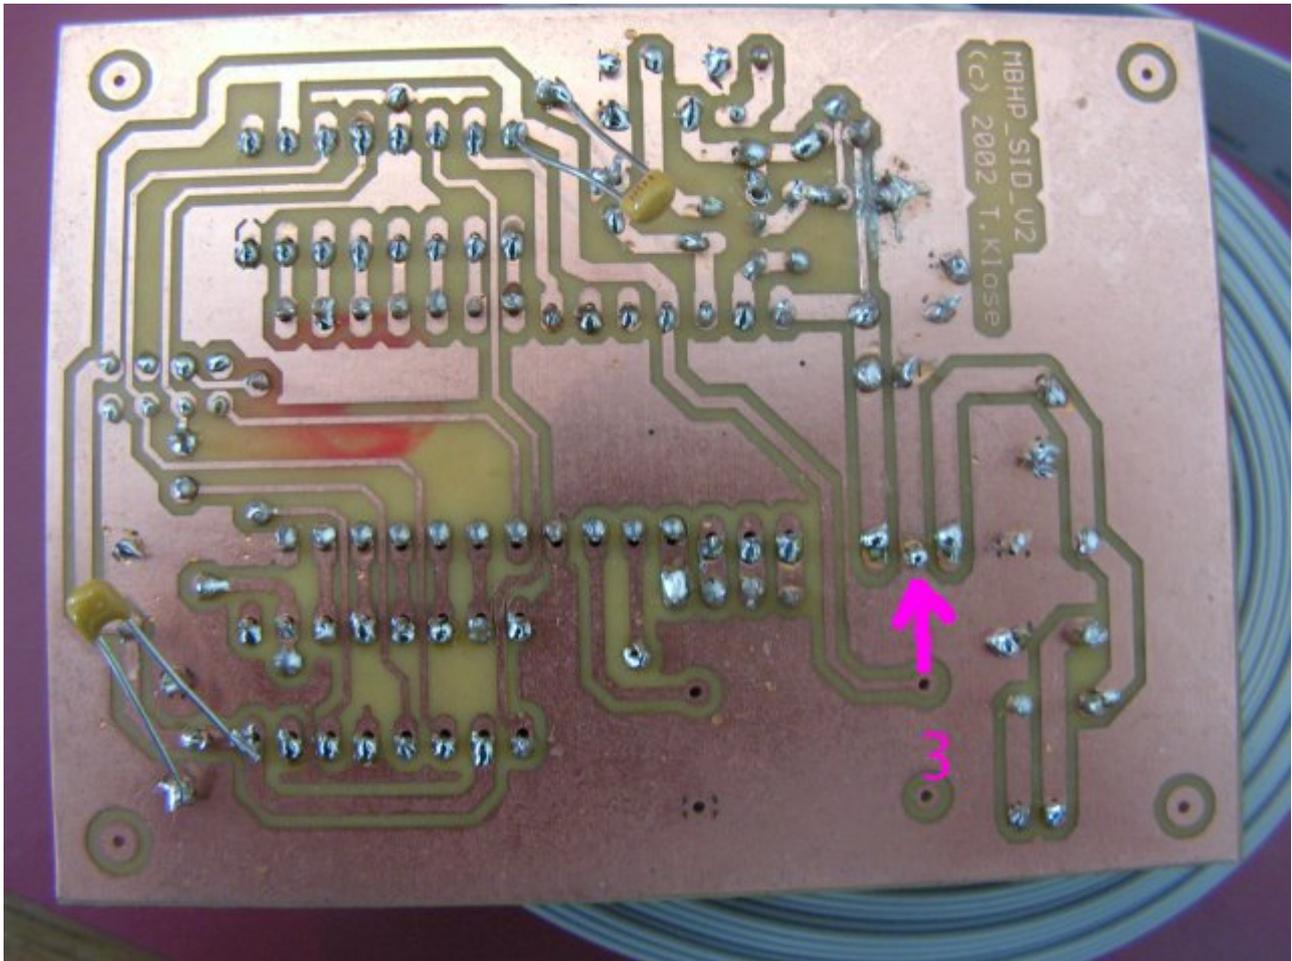
3: this seems to be a bad ground connection directly at the 78xx - it can lead to the wrong voltage. Here the same: just solder the pads again, it will help

And same like above: the long cap legs need to be cutted, the danger for shorts is too high!
