This gallery shows some pictures of bad solderings - they should prevent you from making the same errors (feel free to add even more pictures here!)

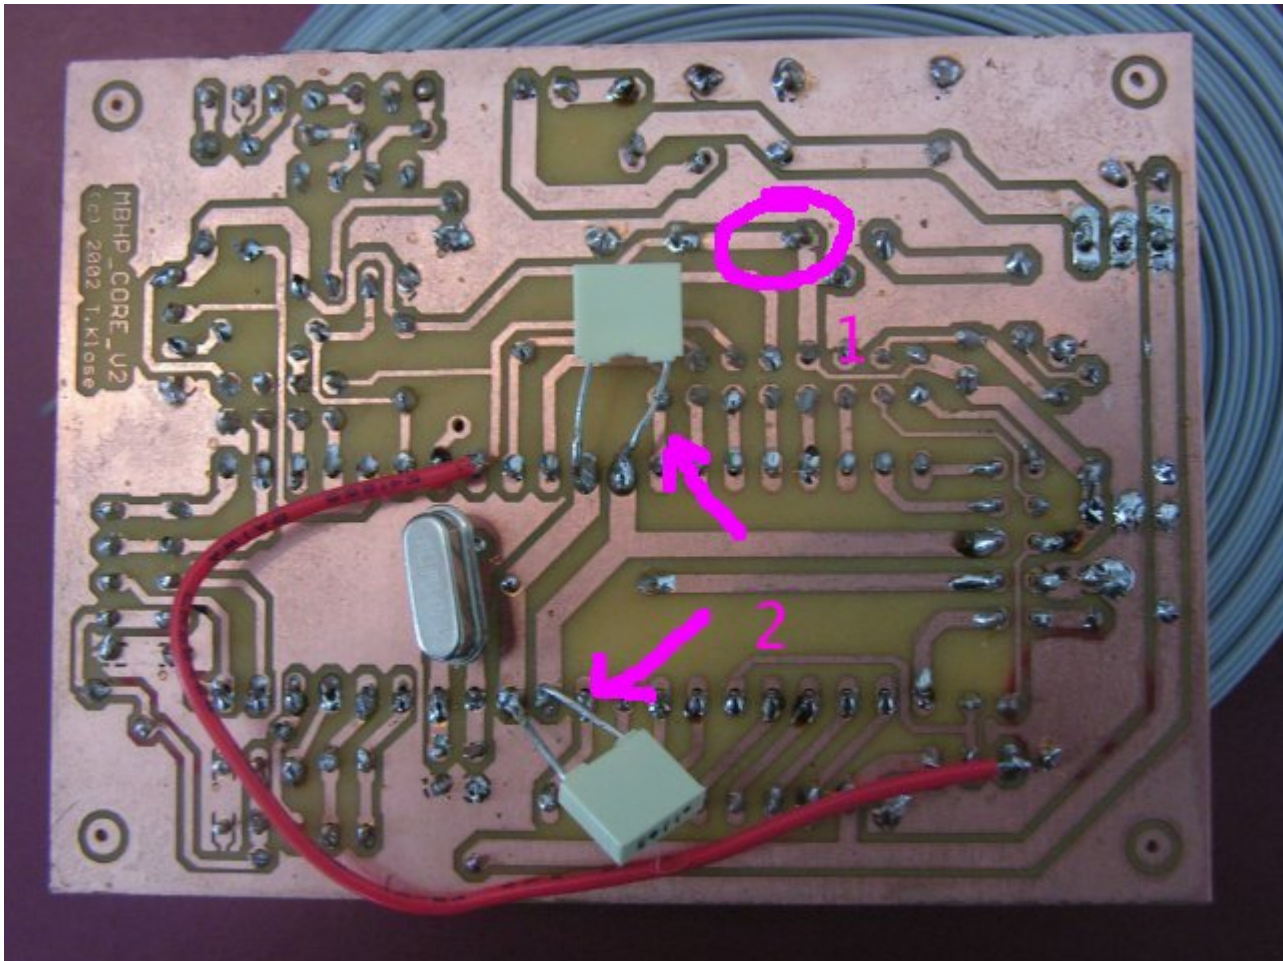
1: The core module has some badly soldered connections (loose), which could lead to failures. There are also missing solderings (e.g. 33pF cap below crystal). It makes sense to solder each pad again, the [Soldering](#) guide in the Wiki gives some useful tips

2: The legs of the caps should be cut, otherwise they can cause a short circuit which can damage the PIC!

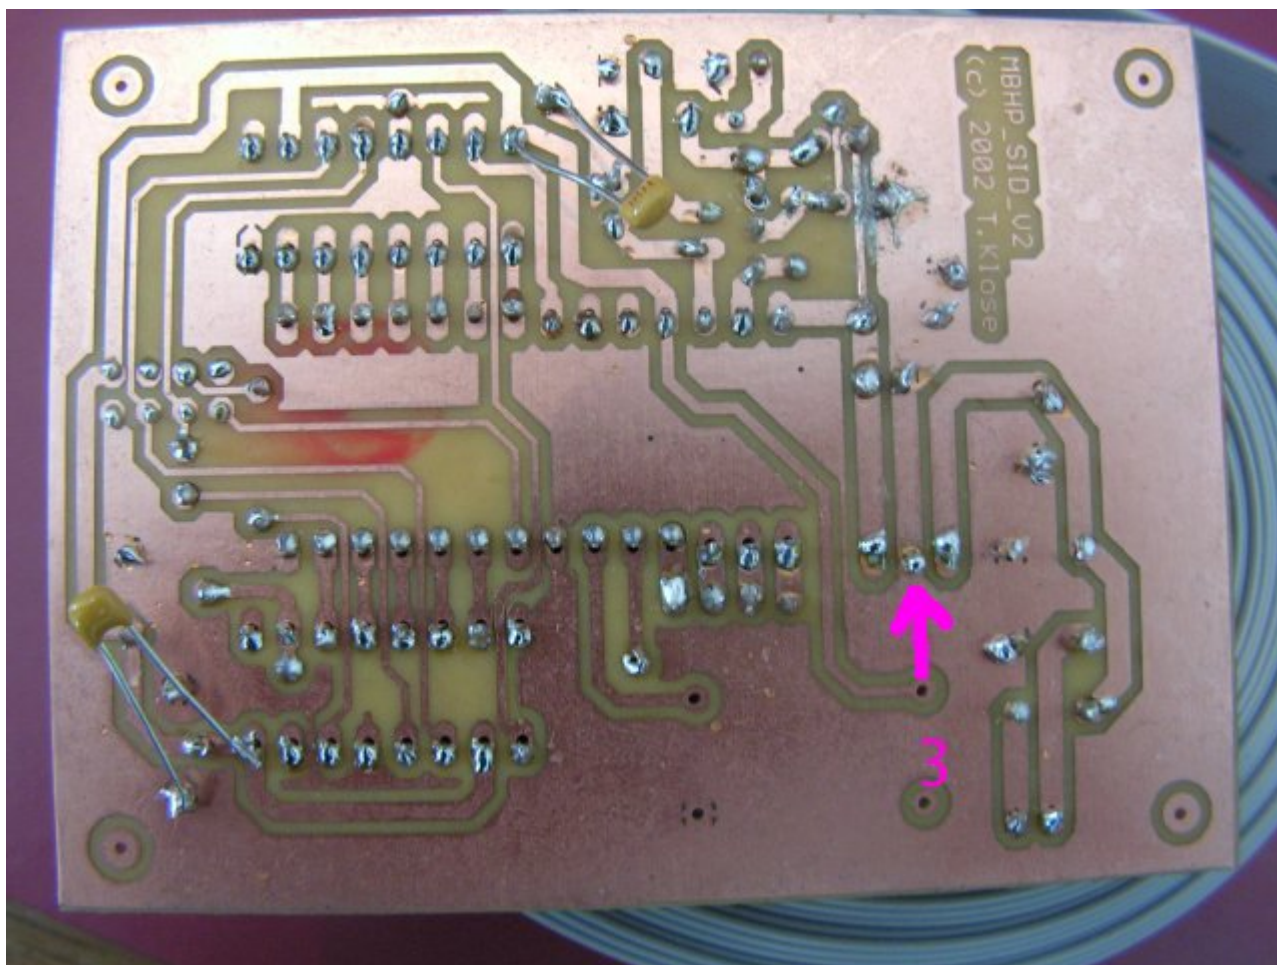
3: This seems to be a bad ground connection directly at the 78xx - it can lead to the wrong voltage. Here the same: just solder the pads again, it will help
And same as above: the long cap legs need to be cut, the danger of shorting out is too high!
