Bad Solder Joints

This gallery shows some pictures of bad solderings - they should prevent you from making the same errors (feel free to add even more pictures here!)

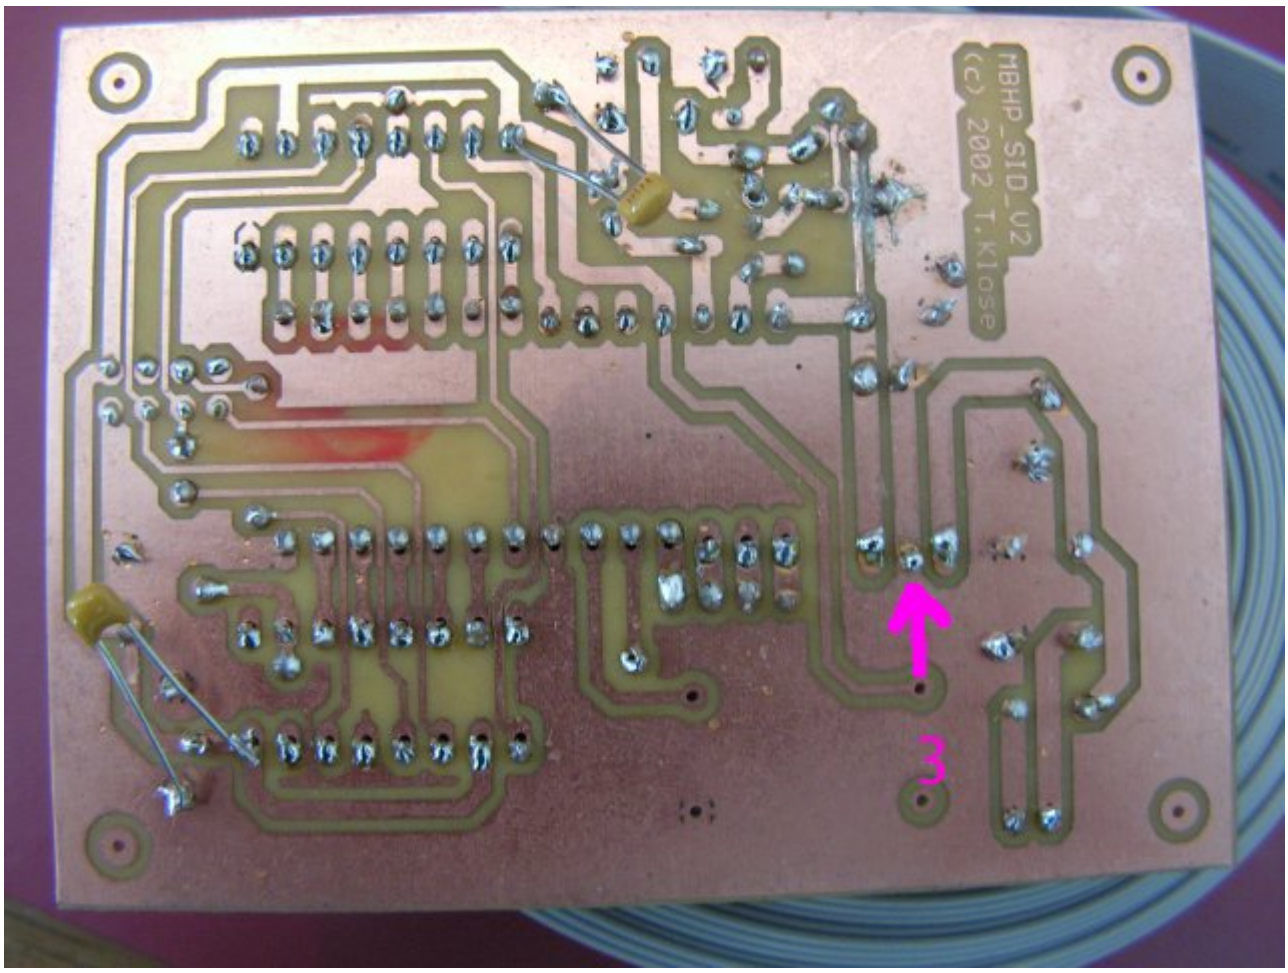
3: This seems to be a bad ground connection directly at the 78xx - it can lead to the wrong voltage. Here the same: just solder the pads again, it will help
And same as above: the long cap legs need to be cut, the danger of shorting out is too high!

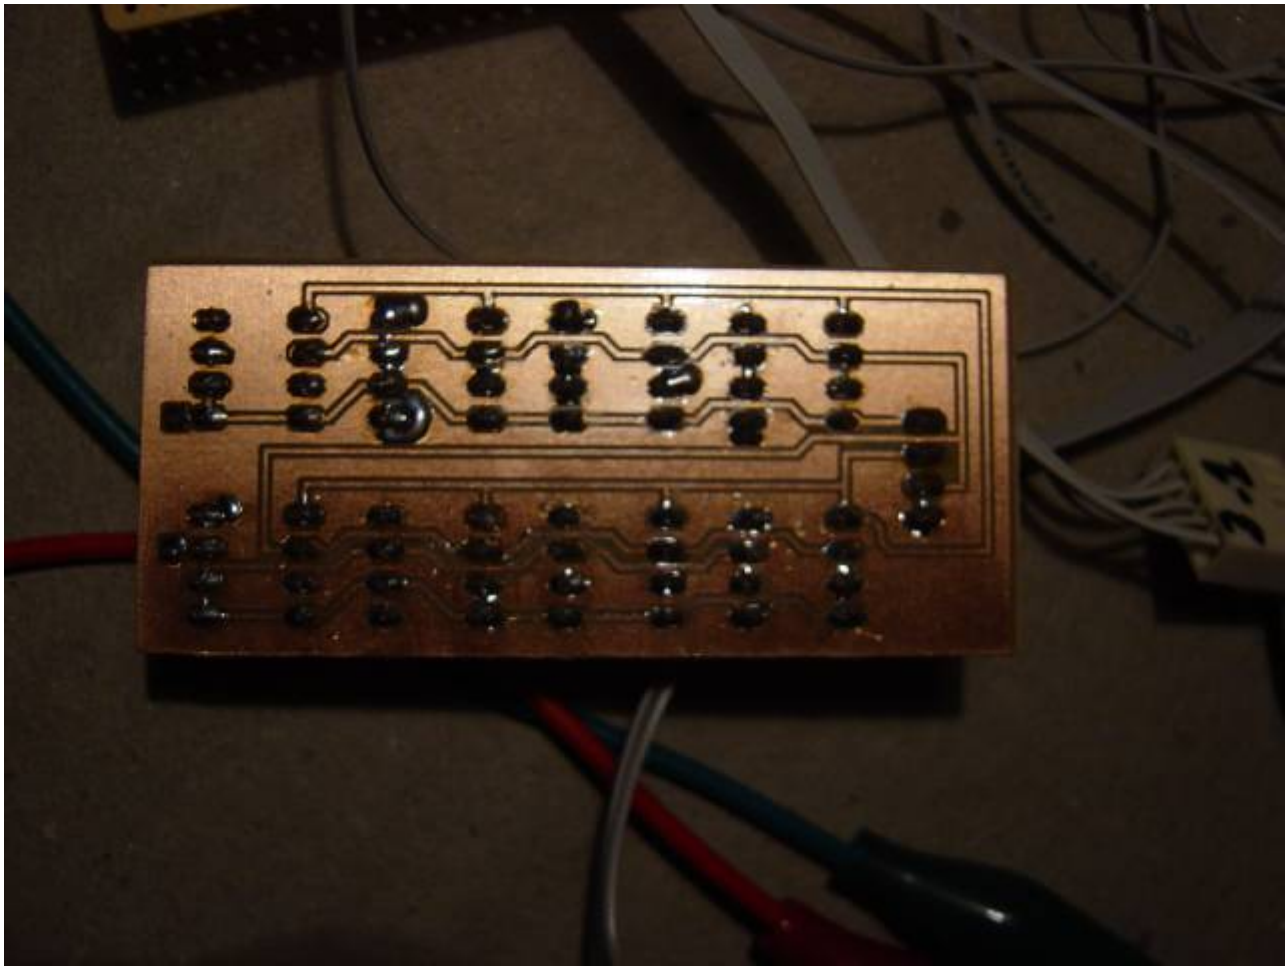
4: This board has too much solder. One experienced midiboxer cleverly said when he saw this pic, “Solder is not glue - more is not better”. This high-res image is zoomed out to 200px wide; zoom in for excellent detail.
