This gallery shows some pictures of bad solderings - they should prevent you from making the same errors (feel free to add even more pictures here!)

From:
https://www.midibox.org/dokuwiki/ - **MIDIbox**

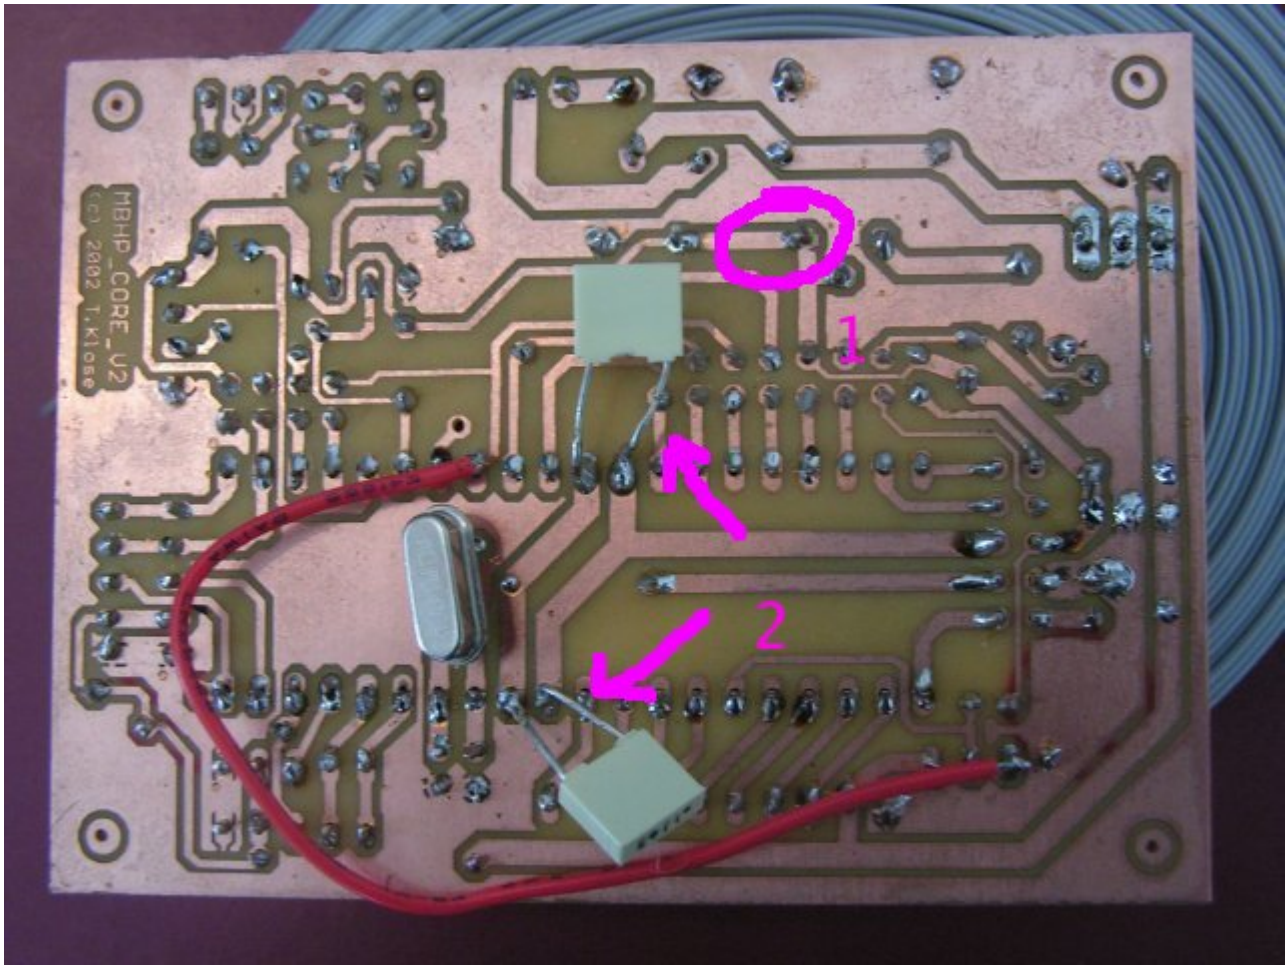
1: The core module has some badly soldered connections(loose), which could lead to failures. There are also missing solderings (e.g. 33pF cap below crystal). It makes sense to solder each pad again, the Soldering guide in the Wiki gives some useful tips
2: The legs of the caps should be cut, otherwise they can cause a short circuit which can damage the PIC!

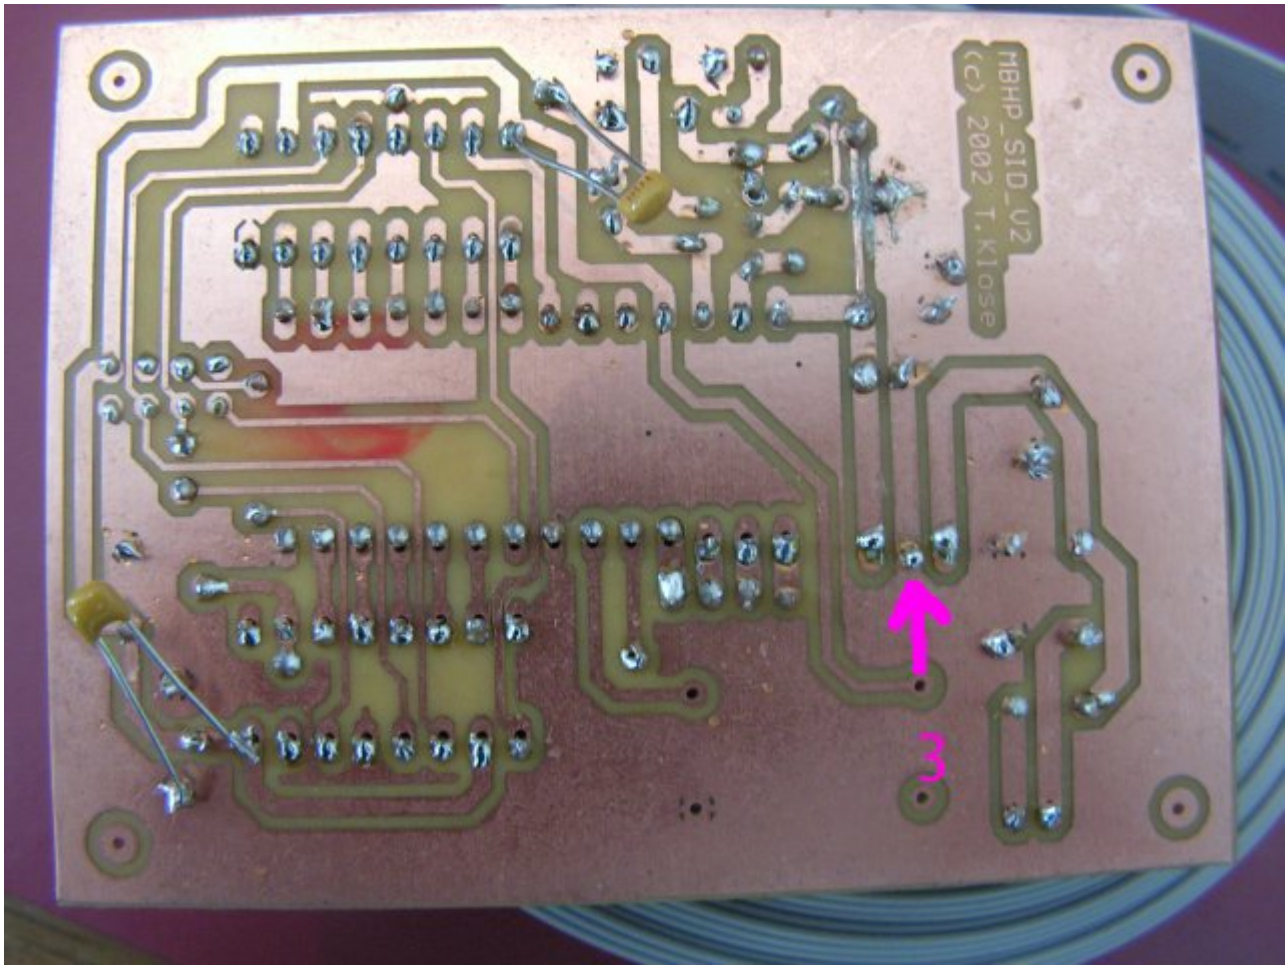
3: This seems to be a bad ground connection directly at the 78xx - it can lead to the wrong voltage. Here the same: just solder the pads again, it will help
And same as above: the long cap legs need to be cut, the danger of shorting out is too high!
