# Bad Solder Joints

This gallery shows some pictures of bad solderings - they should prevent you from making the same errors (feel free to add even more pictures here!)

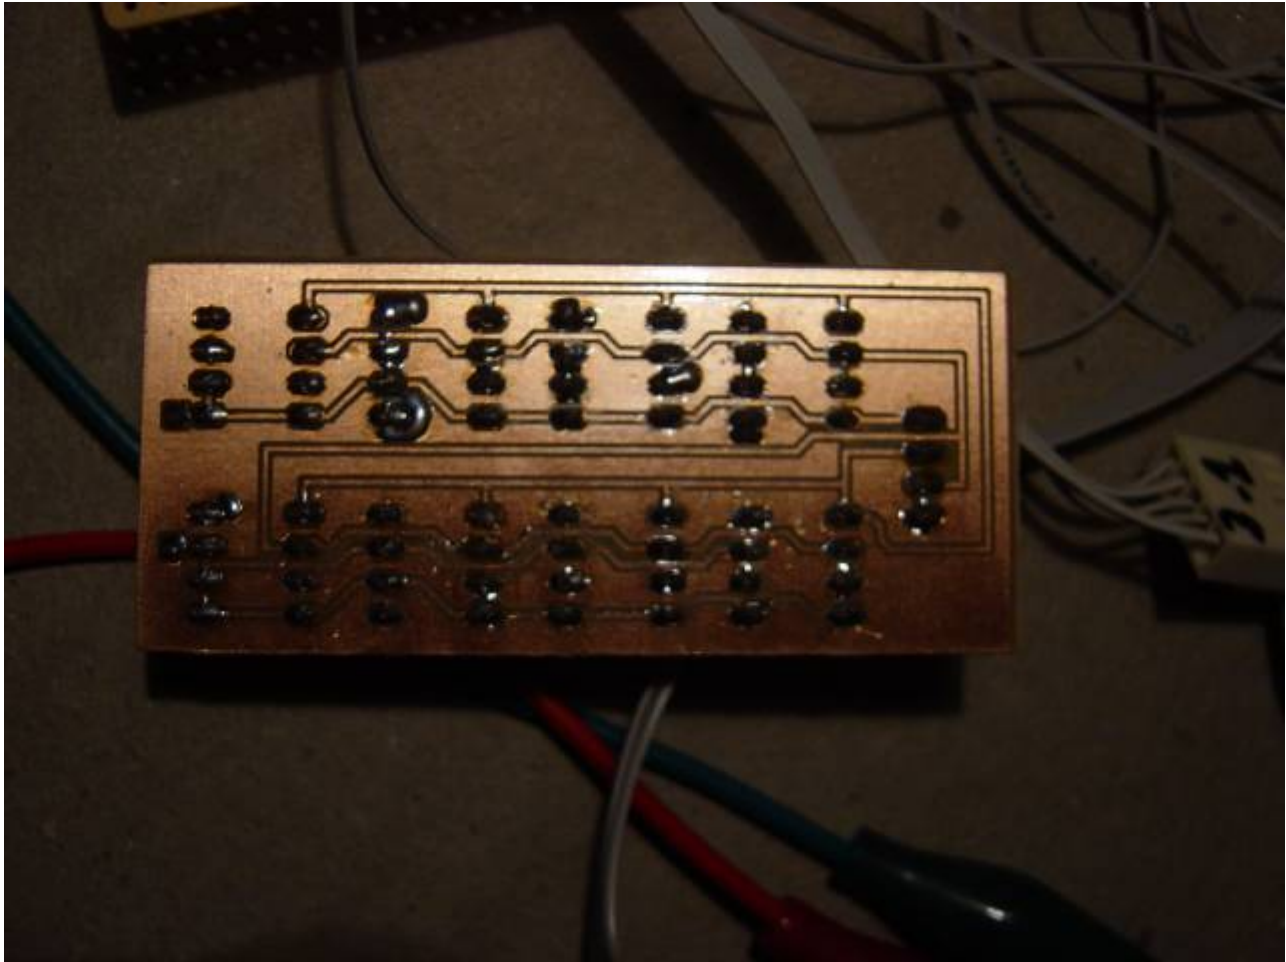
4: This board has too much solder. One experienced midiboxer cleverly said when he saw this pic, "Solder is not glue - more is not better". This high-res image is zoomed out to 200px wide; zoom in for excellent detail.
