This page lists the known errors on the gm5x5x5 PCBs. There are no known issues with the bulk order run (white pcbs), the following information is valid **only** for the prototype run (green pcbs).

Bulk Order #1 (white pcb, rev 1.0)

Prototype Run

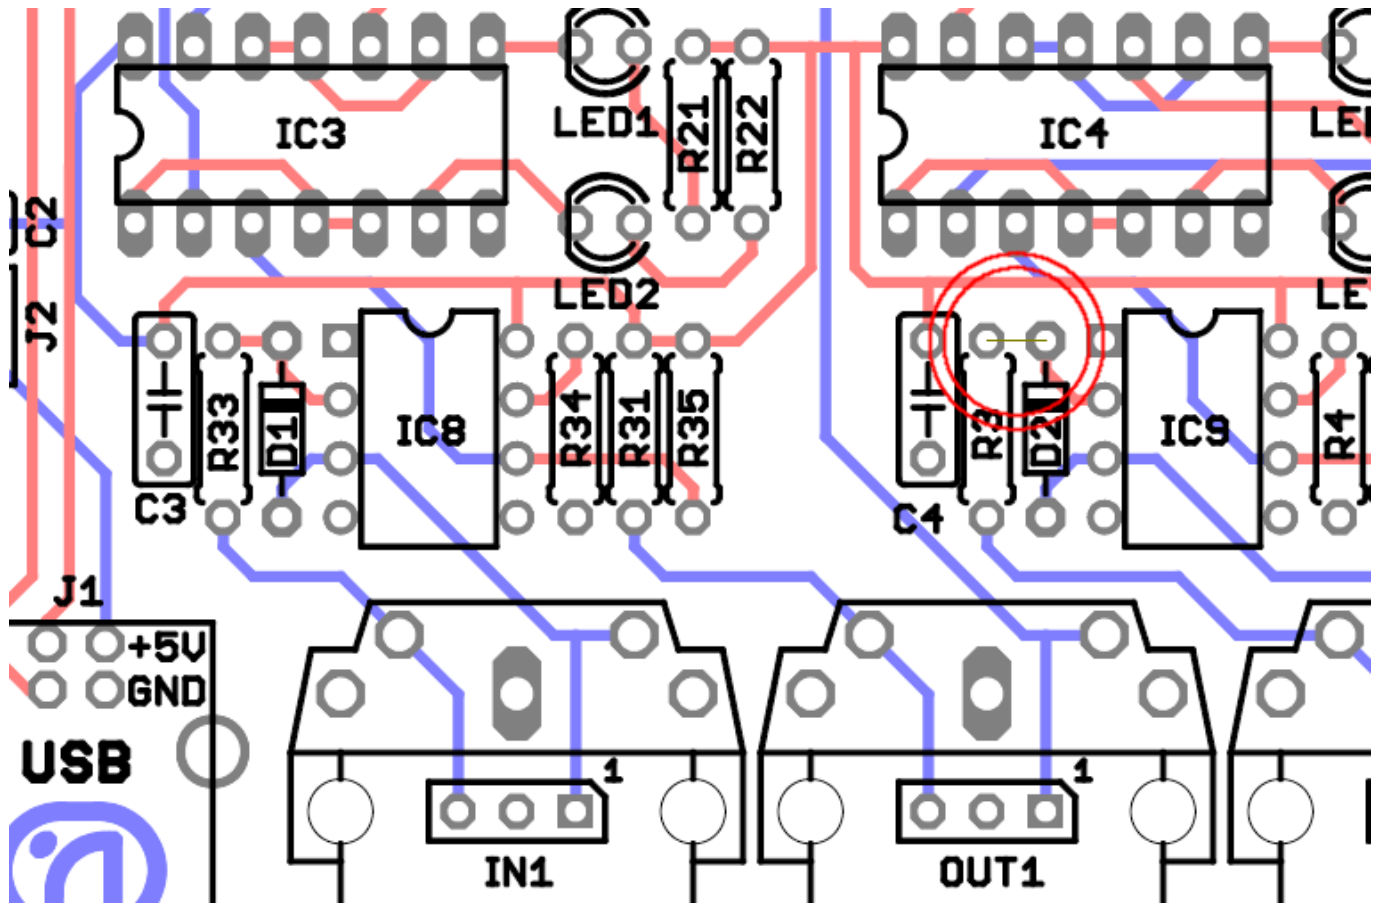
#2 MISSING TRACK

Problem: A track between D2 and R3 is missing.

Solution: Bridge the pins.
